## Water Intrusion Report & Recommendations

### Oregon Hall - Restroom 191

October 1, 2021

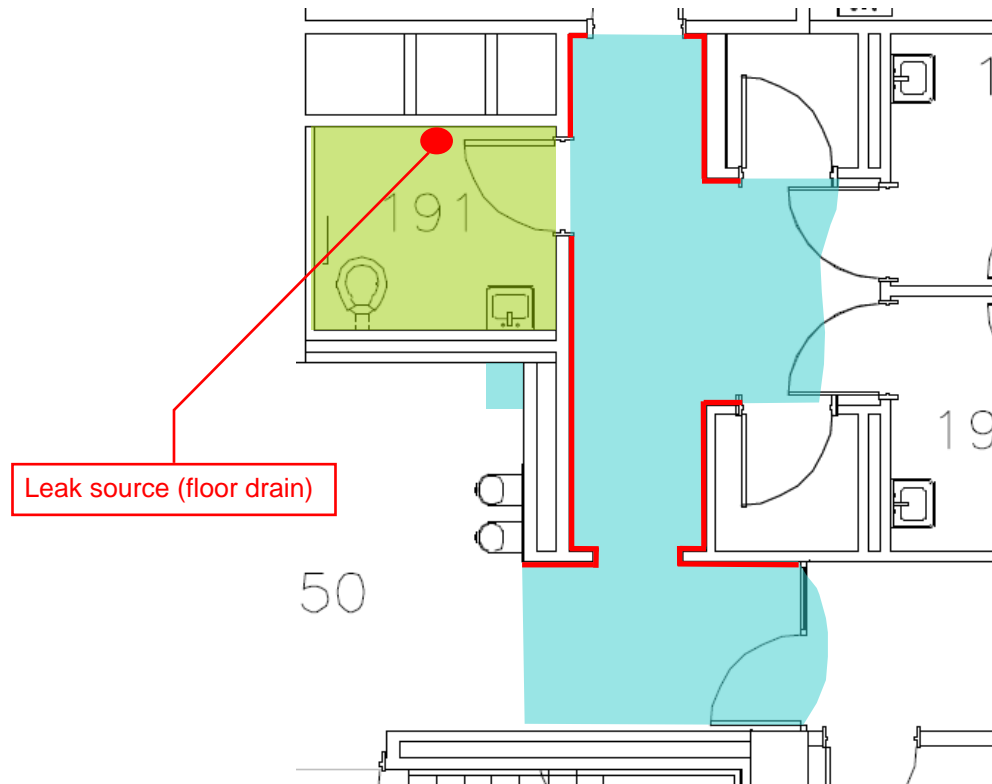
**\*NOTE: LEAK SOURCE WATER IS CATEGORY 3 (BLACK WATER). PLEASE DISINFECT ALL IMPACTED SURFACES FOLLOWING REPAIRS AND BULK CLEAN UP.**

**\*NOTE: ALL IMPACTED GYPSUM BOARD WALLS HAVE ASBESTOS-CONTAINING JOINT COMPOUND AND TEXTURE. ANY IMPACTS TO THESE WALLS MUST BE PERFORMED AS AN ABATEMENT TASK.**

- FINDING:** Ceramic tile floor has remnant standing water  
**RECOMMENDATION:** Extract remaining standing water and disinfect all flooring surfaces
- FINDING:** Rubber-backed carpet squares are saturated in these areas. Water was observed beneath the carpet on concrete in multiple locations.  
**RECOMMENDATION:** Remove, disinfect, and dry all impacted carpet squares. Dry and disinfect concrete substrate prior to carpet tile replacement.
- FINDING:** Asbestos-containing gypsum board walls wet behind wood baseboard (floor up to ~4").  
**RECOMMENDATION:** Remove wood baseboard, isolate impacted area with polyethylene critical barriers, and place dehumidifiers to dry impacted surfaces. Do not use carpet fans/high velocity air movement to dry walls due to presence of asbestos in the joint compound.
